Lagoon Solids Removal and Solid Separation Improvement at a Dairy Farm

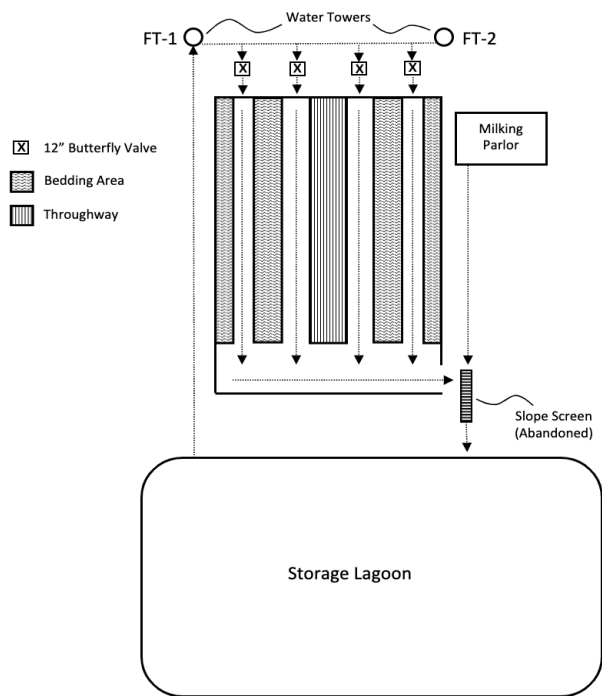
Figure 1. The layout of FM Dairy Freestall Barn, Milking Parlor, and Manure Management System.

FM Dairy is located in Boone County, Missouri, and is home to a herd of 140-160 lactating cows. The dairy used mattress bedding with supplemental cedar shavings (89 cubic feet per day) in a freestall barn, the layout of which is shown in Figure 1.

The 100-foot by 200-foot freestall barn had four flush alleys. The alleys were served by two flush water towers that were each approximately 14,000 gallons. The barn was flushed two to three times per day, with three times per day being typical. Greater detail provided by the operators revealed the dairy may flush as much as four times per day; morning flush, then scrape, then flush again, followed by flushing around noon and again in the evening. The milking parlor and holding pen were also flushed to the lagoon, but the water contribution was only 2 percent of the total daily flush water usage.

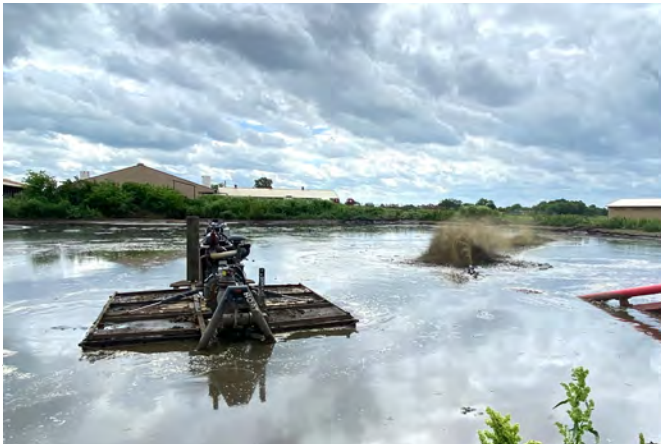
Figure 2. PTO-drive lagoon agitators and agitation boat in action.

The process began by agitating from the shore using two 8-inch lagoon agitators (NUHN, Sebringville, ON, Canada) (Figure 2) connected to two tractors (John Deere, Moline, IL), including an 8100 160 PTO hp using 9 gallons of diesel per hour and an 8295R 242 PTO hp using 13 gallons of diesel per hour.

The agitators require a minimum of 95 hp to produce a maximum flow of 8,000 gallons per minute. As seen in Figure 2, these agitators began operation by breaking up the surface solids using a high-powered jet as they were moved to different locations around the lagoon.

An agitation boat (2067C, Puck Enterprises, Manning, IA) was used once the two agitators had sheared off enough of the upper solids blanket to allow for the boat's draft (Figure 2). The boat is powered by a 6.8L, 275 hp John Deere engine that consumes 5-6.5 gallons of diesel per hour. It operates a Cornell pump with a 17-inch impeller that feeds 3 guns with a total of 4,000 gallons per minute at 30 psi. These guns provide jet propulsion for the boat and break up the solids blanket below the boat. The boat is remote-controlled with an optional GPS setting to allow for line-of-sight operation and automated hands-free operation if chosen.

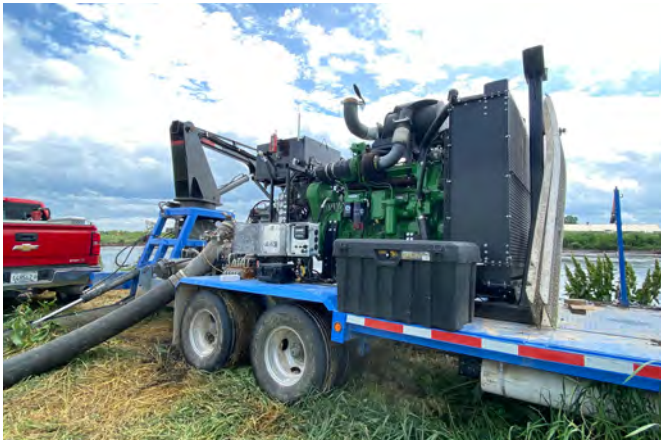
Figure 3. Primary lagoon pump (trailer mounted).

A Zoske (Iowa Falls, IA) pump trailer (Figure 3) was used to deliver the agitated lagoon effluent to the injection sites through an 8-inch, 200 psi hose. The pump trailer consists of a Cornell centrifugal pump powered by a John Deere motor.

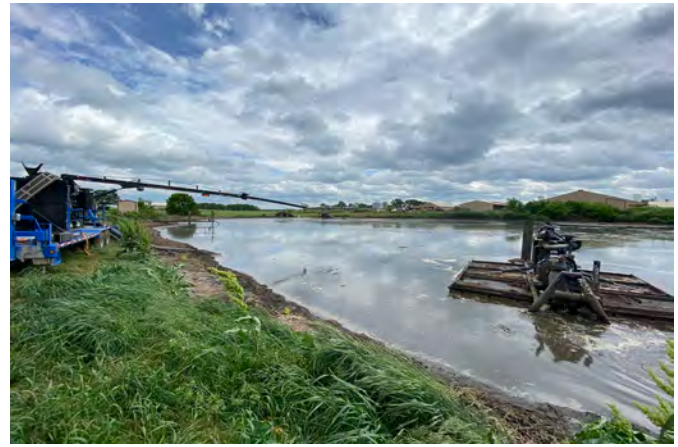
Figure 4. Boom intake and primary lagoon pump.

An Atlas Copco (Rock Hill, SC) compressor was set adjacent to the pump trailer to provide compressed air to unclog the discharge line if needed. Note the "Y" in the discharge line in Figure 4 with a compressed air line attached to one branch. The pump trailer intake line (Figure 4) was then suspended in the lagoon using a boom that is attached to the pump trailer.

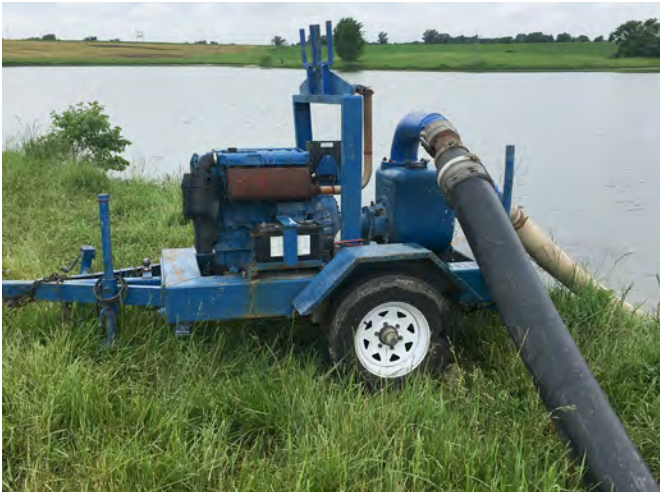
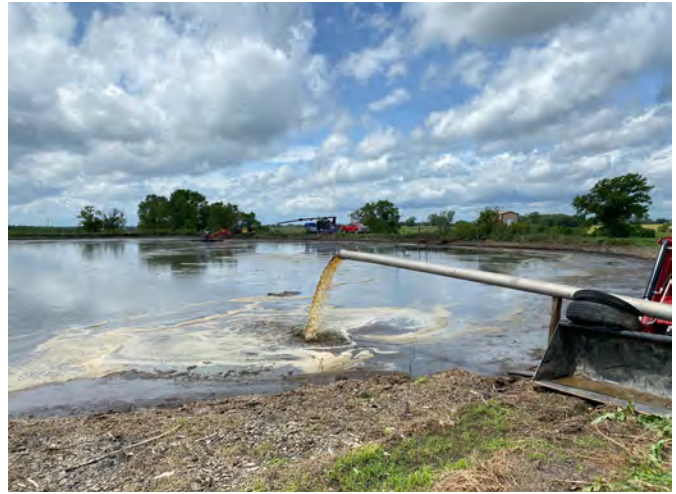
Figure 5. A dilution pump was used to pump water from the nearby lake (left) to the dairy lagoon (right) with agitation boat and lagoon agitation working in the background.

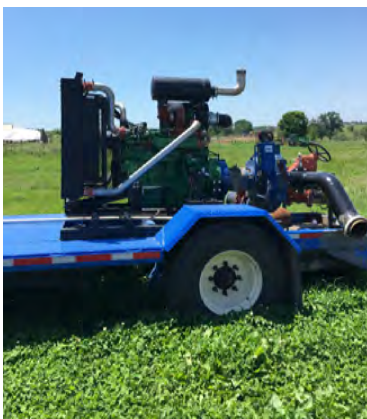
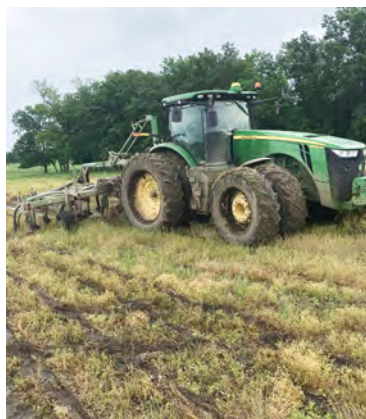
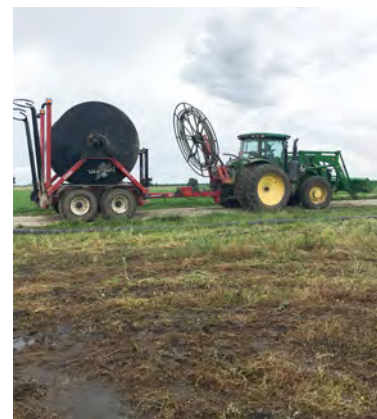
Figure 6. Booster pump (left), application toolbar and tractor (center), and hose cart and humper (right).

The booster pump, consisting of a Smart Turner (Brantford, Ontario, Canada) centrifugal pump paired with a John Deere engine (Figure 6), was used to maintain a flowrate over 1,800 gallons per minute through the drag hose, which was reduced from 8-inch to 6-inch immediately after the booster pump.

A toolbar (Hydro Engineering, Norwood Young America, MN) with 13 Dierich shanks on 24-inch centers was used for manure injection. The toolbar was mounted to a John Deere tractor (8320R, 263 PTO hp using 15 gallons of diesel per hour), as seen in Figure 6.

The injection equipment was supported by a John Deere (8285R with 239 PTO hp using 15 gallons of diesel per hour fuel use) that used a Zoske Open Spool Hose Humper to feed the drag line from a Zoske Raptor 32 Hose Cart (Figure 6). The hose cart has a capacity of either 16 sections of 8-inch hose in 660-foot lengths or 32 sections of 6-inch hose in 660-foot lengths and is capable of layout speeds up to 10 miles per hour when the spool is under power.

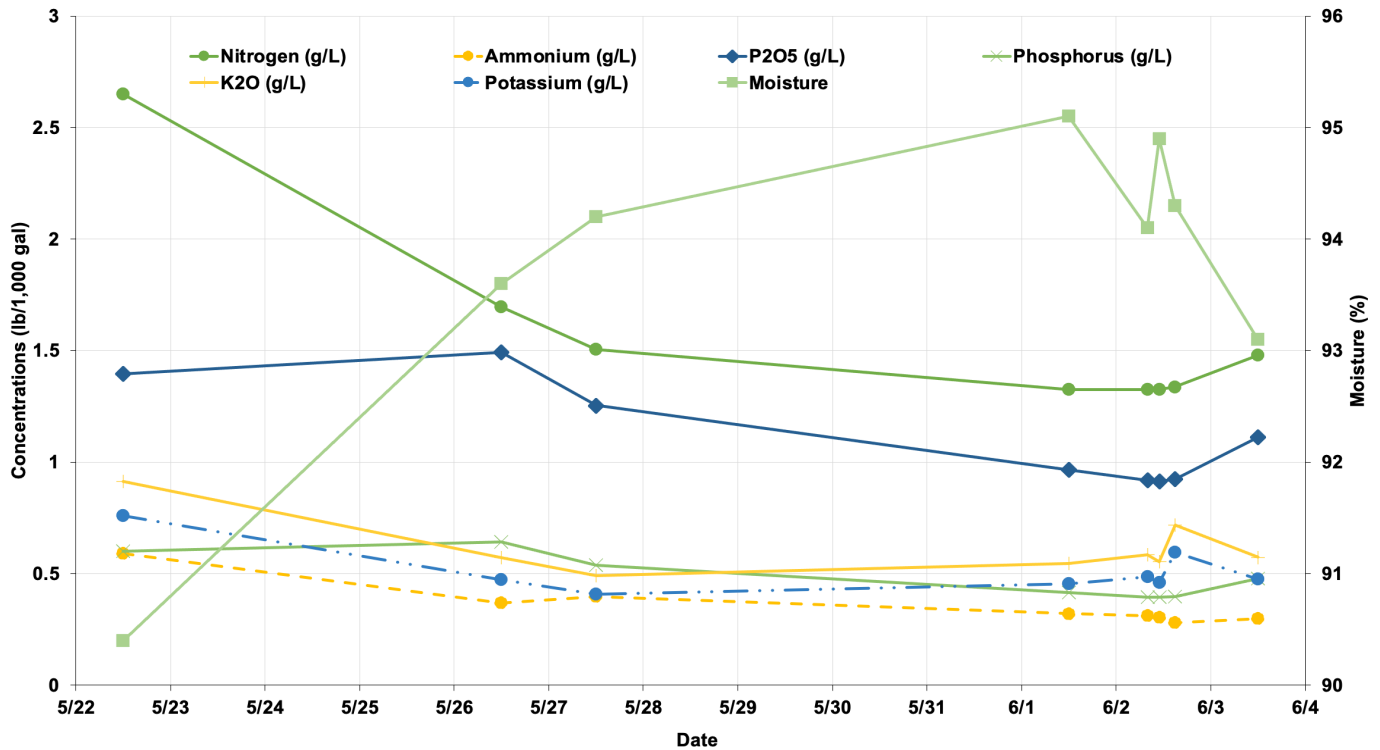
Figure 7. Concentrations and moisture content of slurry samples from the lagoon.

The soil had been tested for existing nutrient content within three years of land application discussed herein. GPS and application flow data were combined by software made available by John Deere, the output of which was provided to the farm to show how many gallons of slurry had been applied to each acre. It is worth noting that publishing limitations on image resolution prevented us from sharing those maps in this case study. Extension used the sample concentrations noted in Figure 7 to produce the mass application table displayed in Figure 8.

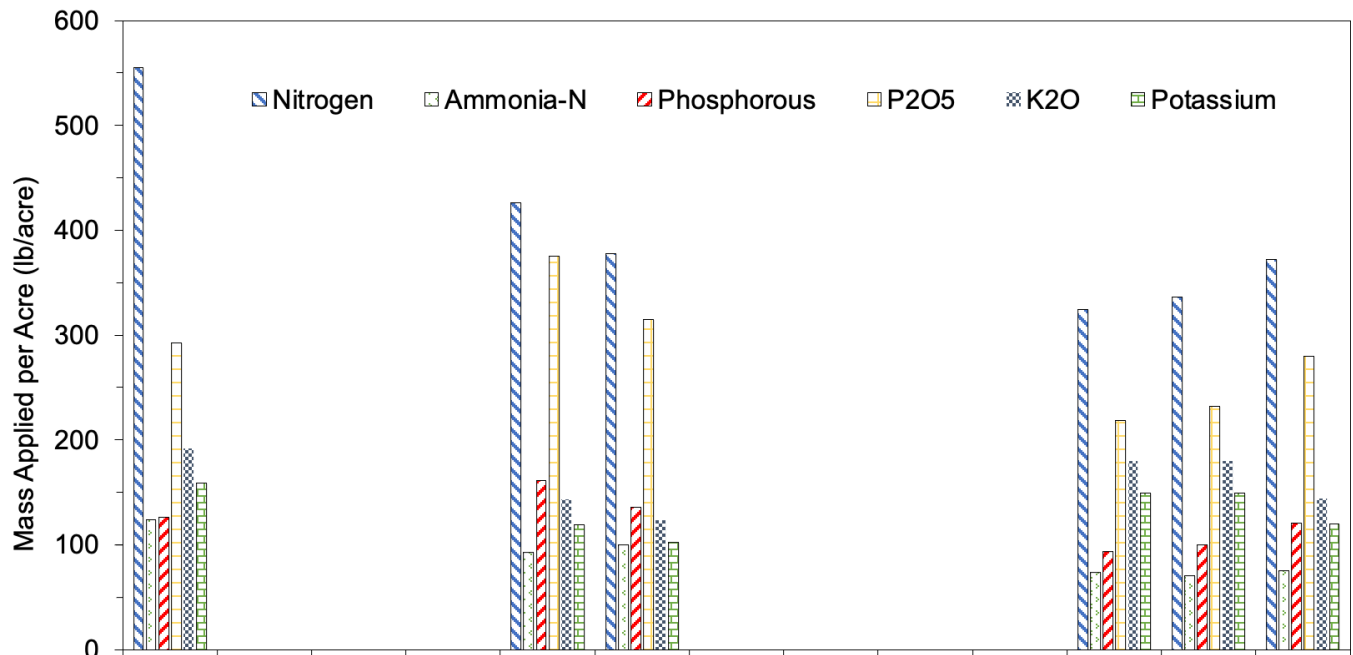
Figure 8. Amount of manure nutrients land applied onto the nearby fields, calculated based on sample analysis and amount of effluent applied.

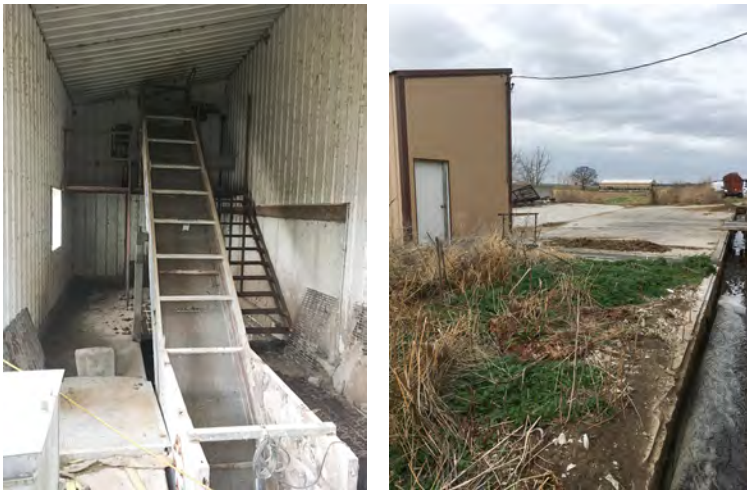
Figure 9. Abandoned manure screen (left) and concrete pad for storing separated solids (right).

The manure flush system at FM Dairy had been discharging directly into the lagoon for a few years prior to the clean-out. The Dairy operated an inclined conveyor manure separator with a PVC paddle for manure separation. The separator system was installed in a small enclosure (Figure 9) with an auger that conveyed solids to a drying pad for drying and storage. The manure separation was halted when the unit fell into disrepair, and the lagoon has since been receiving most of the manure solids and woodchips from the freestall barn.

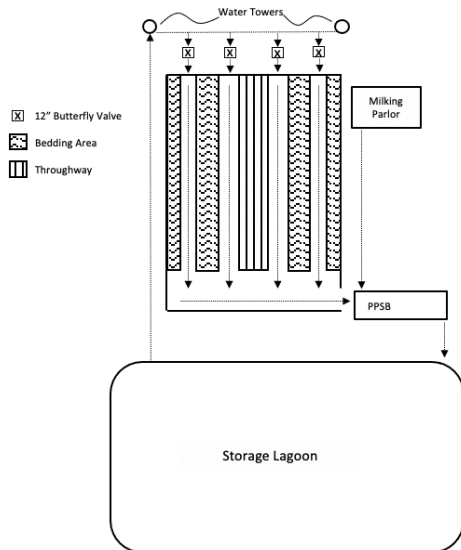
Figure 10. Revised FM Dairy manure separation layout, with a PPSB system separating manure solids and woodchips.

The Dairy worked with USDA NRCS to develop layout plans for the site. The collection gutter for flush water and the slope screen building were demolished, and the site was reconfigured, as seen in Figure 10.

Construction began by grinding down the existing drying pad, filling in the flush collection trough, and completing the earthwork for the PPSB (Figure 10). One of the most considerable challenges of installing the PPSB was managing the hydraulic grade line of the flush water from the end of the freestall to the lagoon. Great care was taken to eliminate pooling as much as possible, hence the need to grind down the existing concrete drying pad.

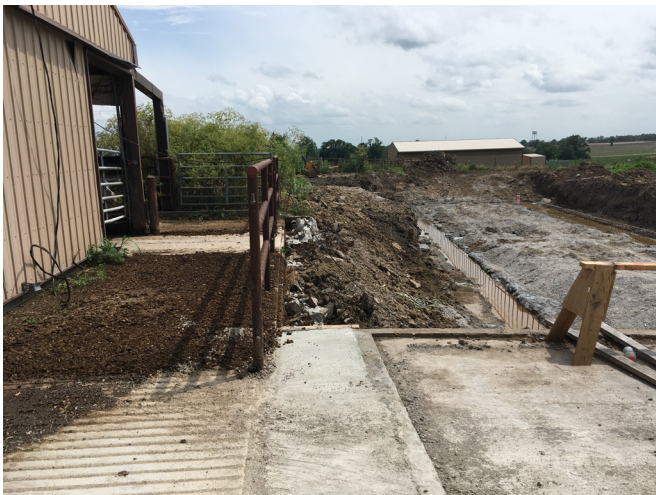
Figure 11. Early construction of the PPSB with flush trough and old drying pad.

Figure 11 shows the freestall barn to the left. The edge of the freestall flush is in the foreground. The flush alley from the holding pen and milking parlor can be seen in the background on the left. This PPSB was

designed to allow flush water from the pen and parlor to cascade over the vertical wall near the maintenance ramp, although it is recommended that all flush water enter the PPSB by flowing down the maintenance ramp. Existing grade limitations made this design exception necessary. The old flush collection trough can be seen filled in with white concrete in the foreground and demolished in the background just past the red iron fence. The drying pad in the foreground on the right has been ground down to allow flush water to be funneled down the maintenance ramp to the PPSB, which is in the background on the right. The drainpipe for the PPSB can be seen in the far-right background as a white PVC pipe with red marking. The footings for the PPSB were poured and wall forms set once the site dried, as seen in Figure 12.

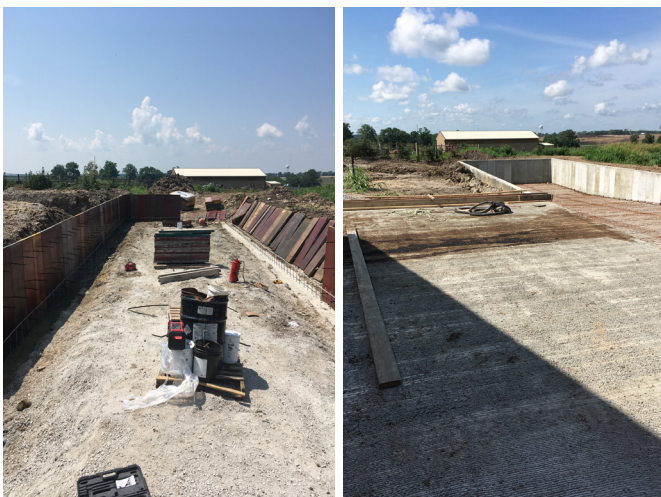
Figure 12. PPSB with concrete forms being set (left) and construction nearing completion (right).

The top photo in Figure 12 shows the PPSB further along in construction with a new upper pad poured and grooved, PPSB walls set, and the rebar reinforcement for the floor in place. The upper pad had been grooved to provide better traction in wet and especially icy conditions. A 6-inch form for a curb can be seen in the

background on the left side. This curb helps direct the flush water to the PPSB. The grade of the maintenance ramp on the bottom side of Figure 12 is made evident by the increasing height of the wall from the foreground to the background. The 8-inch PVC slip joint for the discharge pipe can be seen in the back-right corner of the PPSB. The PPSB was put into operation as soon as the floor was dry. The operators of FM Dairy had

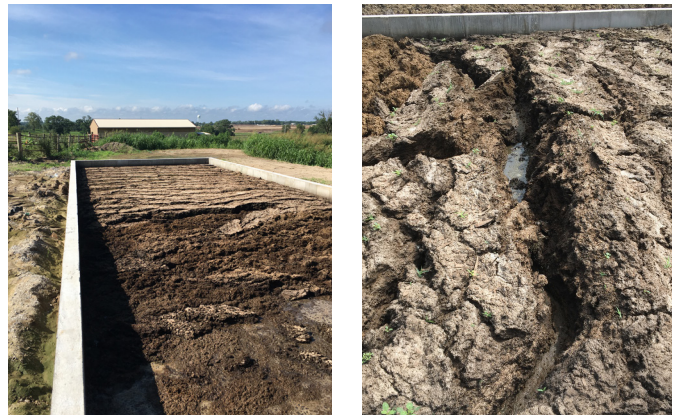
Figure 13. Mat formation on PPSB (left) and large cracks in mat (right).

The fiber bedding of cedar shavings at FM Dairy quickly forms a dense mat in the PPSB, Figure 13. The dense mat results in standing water on the maintenance ramp, which was not seen at other installations that utilized sand bedding with a sand lane prior to the

The flush water from the pen and parlor keeps the elevated pad relatively clean. There is some build-up of manure in the section before PPSB that results from a non-flushed section between the freestall alley and the pen/parlor alley. There is an obvious difference between the older mat in the background and the newer mat in

the foreground, Figure 13. The older mat is dryer and displays evidence of significant upheaval and compaction/expansion, as evidenced by large cracks. The physical characteristics of the mat suggest a high hydraulic loading rate on the system. Mats from other installations did not exhibit the same degree of undulation. A comparison can be made between FM Dairy and BR Dairy (see MU Extension publication EQ302, Considerations of Pull-Plug Sedimentation Basin for Dairy Manure Management), which had a relatively smooth mat across its surface. Table 4 shows the hydraulic load comparison between the two PPSBs.
