Dry nitrogen fertilizer quality: Impact on spreading variability

Year 1 report

Peter Scharf, University of Missouri, Plant Sciences Division

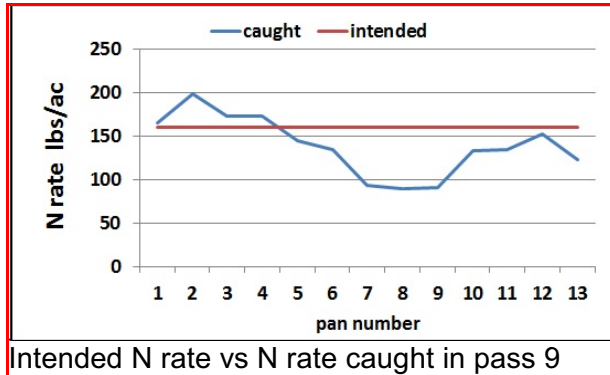
Intended N rate vs N rate caught in pass 9

In both pass 6 and pass 9, N rate was higher than intended on the left and lower than intended in the middle. In pass 9, N rate on the right was near the intended rate, but was much lower than intended in pass 6. This is likely partly because the pans were not in place at the time pass 5 was applied, so that the overlap from pass 5 was not caught.

We had recorded the GPS location of each pan. Due to the relatively large differences between the intended and actual N rates, we went to several catch pan locations in September and hand-harvested the grain at those locations. In both pass 6 and pass 9, yield was higher at the locations where we caught more fertilizer in the catch pan, and lower at the locations where we caught less fertilizer in the catch pan. Applying the relationship between N rate and yield in the graph at the right to the catch all the way across the pattern, predicted yield is 149 bushels with the observed pattern and 163 bushels if the intended N rate had been applied everywhere. **The uneven pattern and lower-than-intended N rate resulted in a yield penalty that we estimate at 14 bushels/acre.** A similar outcome was found in pass 6.

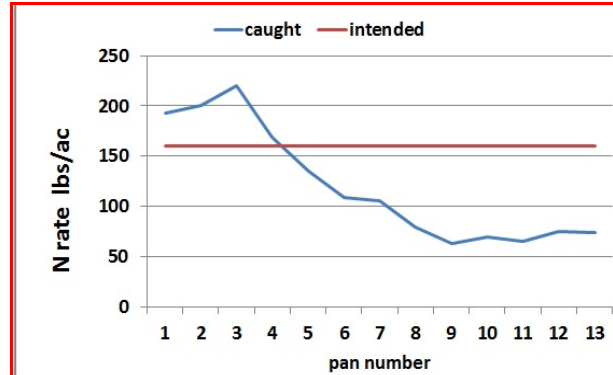
Intended N rate vs N rate caught in pass 6. Pans were not in place during pass 5, so overlap from pass 5 was not caught (right side of graph).

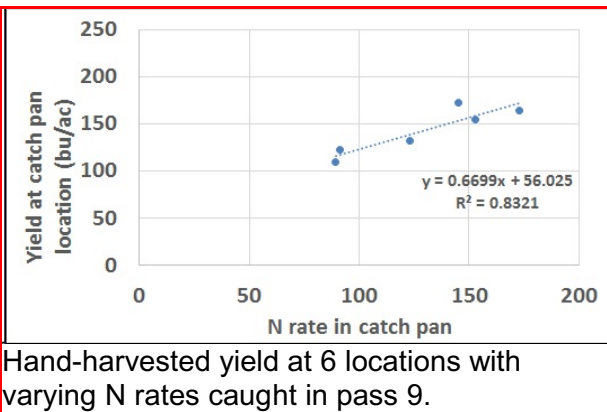
Hand-harvested yield at 6 locations with varying N rates caught in pass 9.

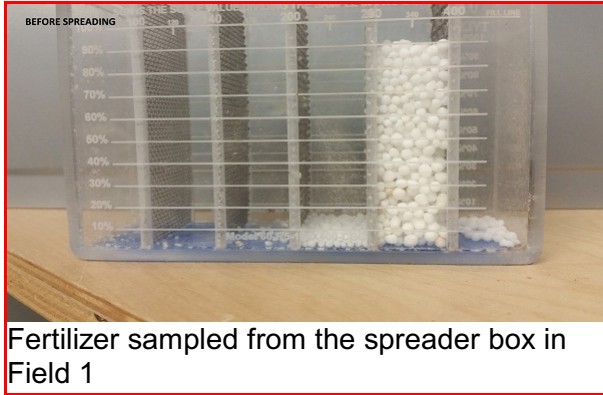
Fertilizer samples from the spreader box and from the pans were put into SGN (size guide number) sieves to assess particle size. Initial quality appeared good. About 20% breakage of the urea granules was seen due to spreading (impact with spinner vanes).

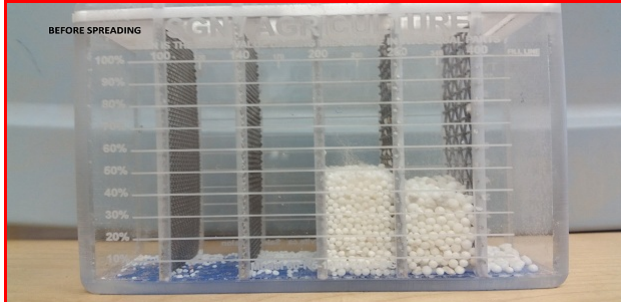
Fertilizer sampled from the dry box used in Field 2

The physical integrity of the fertilizer material did not appear to be a serious problem in any of the fields we tested. I've seen both urea and ammonium nitrate with higher levels of fine particles than we saw in any of the fertilizer that we sampled from the dry boxes in these six fields.

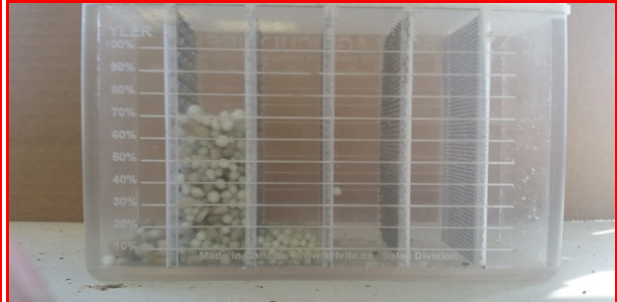
Fertilizer sampled from the dry box used in Field 3

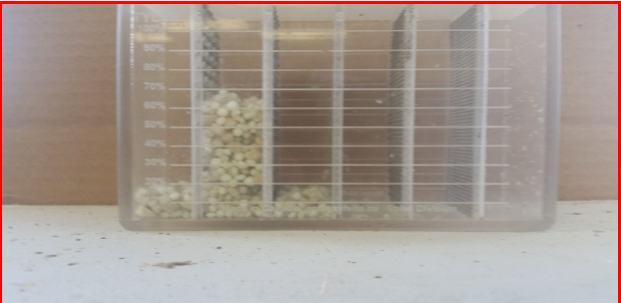
Fertilizer sampled from the dry box used in Field 4

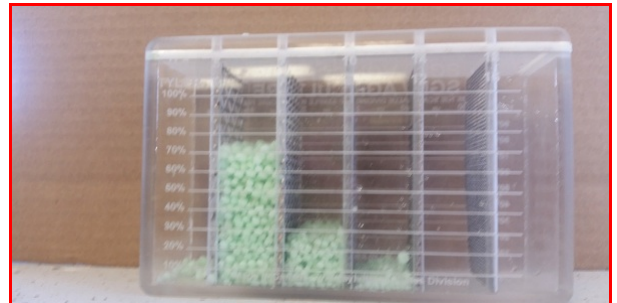
Fertilizer sampled from the dry box used in Field 5

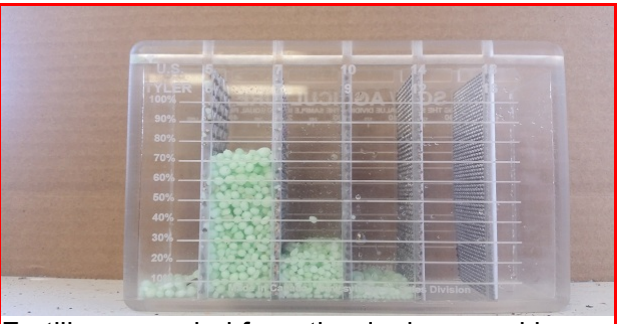
Fertilizer sampled from the dry box used in Field 6
